NEW JERSEY STATE DEPT OF ENVIRONMENTAL PROTECTION TRENTON F/G 13/2
NATIONAL DAM SAFETY PROGRAM. HANOVER LAKE DAM (NJ00459), DELAWA--ETC(U)
AUG 78 D J LEARY

HANOVER LAKE DAM (NJ00459)

PHASE I REPORT
NATIONAL DAM SAFETY PROGRAM

Name of Dam:	HANOVER LAKE DAM
ID Number:	Fed ID No. NJ00459
State Located:	New Jersey
County Located:	Burlington
Stream:	Hartshorne Mill Stream
River Basin:	Delaware
Date Of Inspection:	6,14,19 July 1978

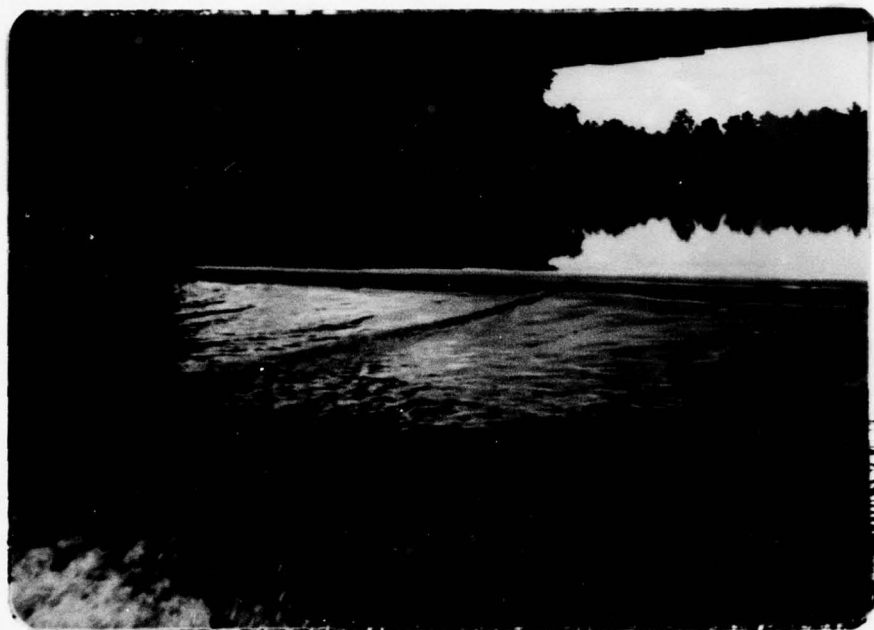
View of spillway looking
upstream.

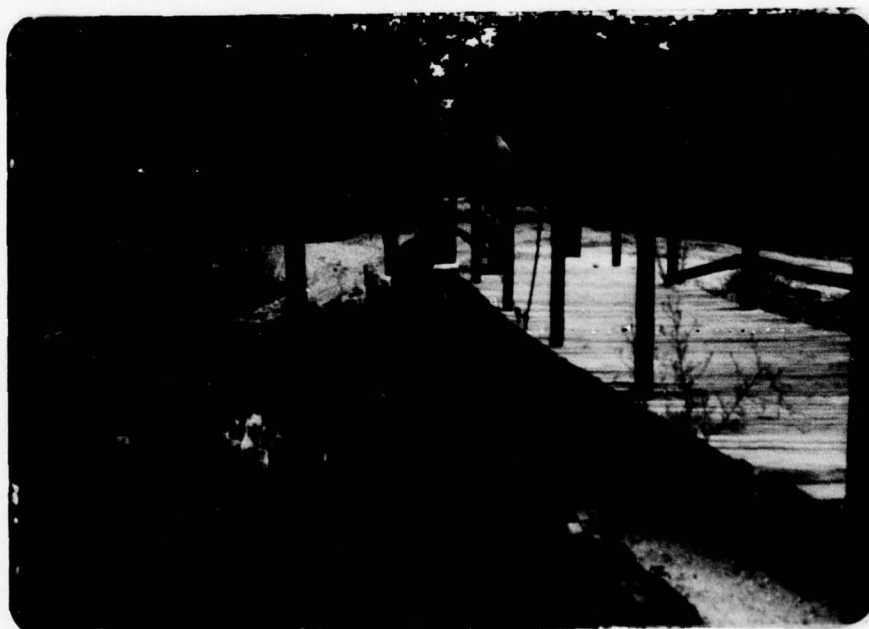
Upstream view of wooden bridge pier abutments. 6 July 1978

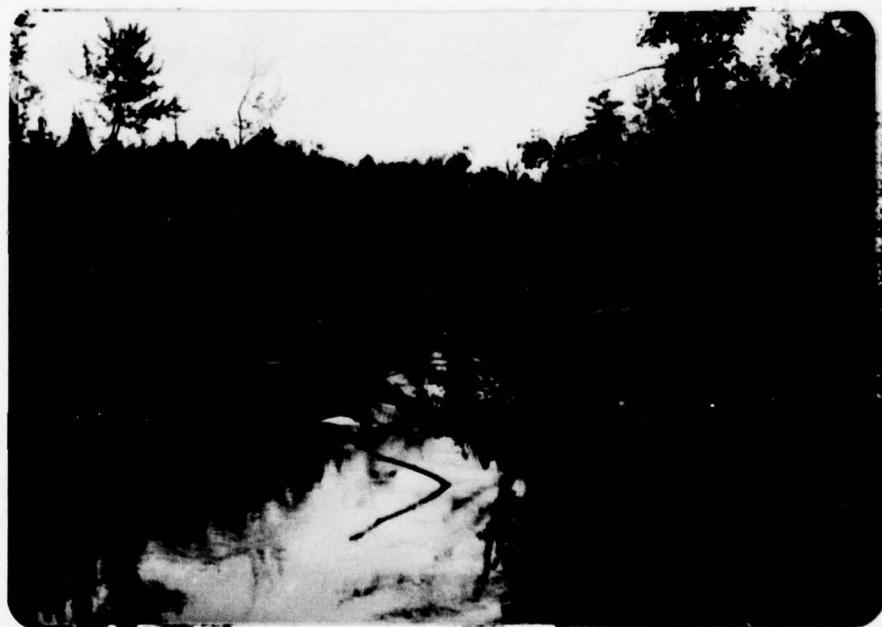
View of discharge channel 6 July 1978
from bridge looking downstream.
